Current positions/ **Hybrid design**

Example 2: Breakout through the bottom of the steel ladle

Rinus Siebring
Manager Technology Refractories
Centre of Expertise Refractories

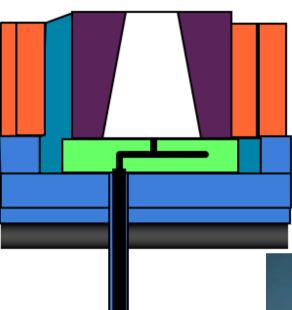
Before 1999:

Bottom life ~ 32 heats

Stirring station

1 purging plug

Purging ~ 12-25 heats

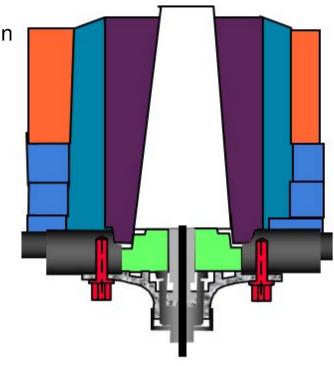
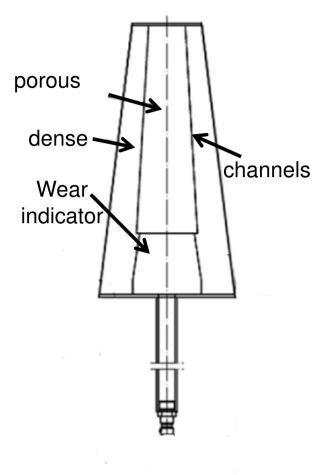
<u>After 1999:</u>

New refractory design

+ Ladle furnace

2 purging plugs

100% purging

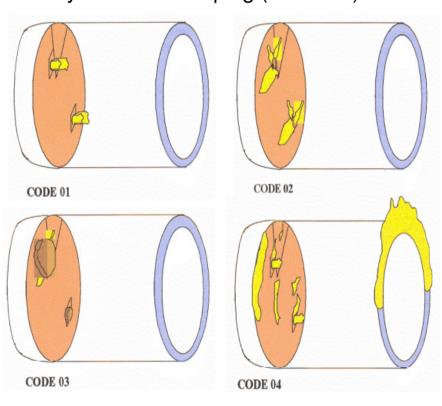
Check/replacement

Check a.s.a.p. after arrival at the tilting stand
Check with nitrogen gas or natural gas
Only flames in the plug (code 1-5)

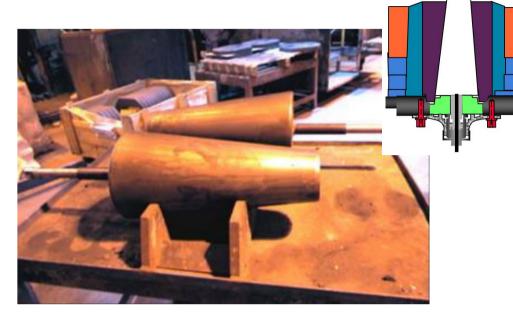
3 mm of mortar

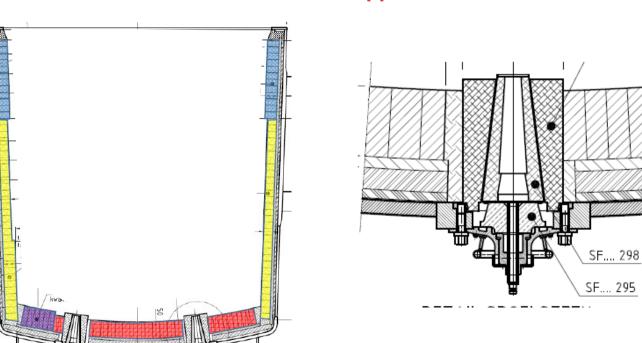
- TATA
- During tapping under the converter a breakout through the purging system (approximately after 2-4 minutes)
- Before this heat, a new purging plug was installed
